## Operational Inspection

Reedham Village Hall

Reedham Village Hall  
Pottle's Lane, Reedham, Norwich, NR13 3HL

Operational Inspection - 15-June-2022 - 08:53 Inspector Martyn Lilley

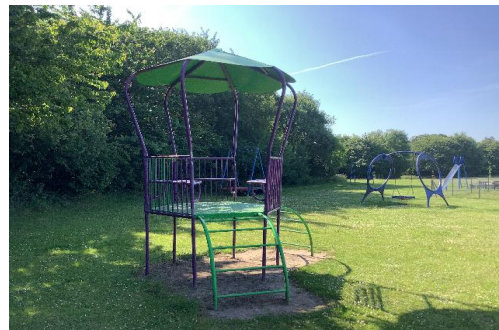
Finger entrapment present - Remove finger entrapment

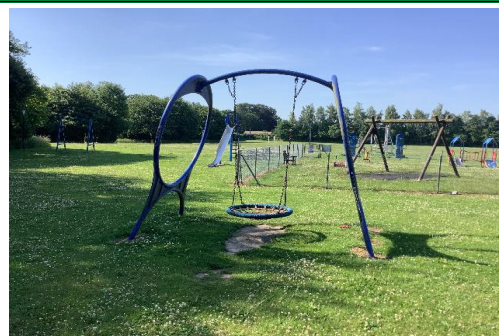
The bushes are worn or missing - Replace worn or missing bushes

The seat has minor damage or wear - Monitor for any further deterioration and replace as required

The chain links are worn in excess of 40% and require renewing - Replace worn chains

Seat low - Raise to comply

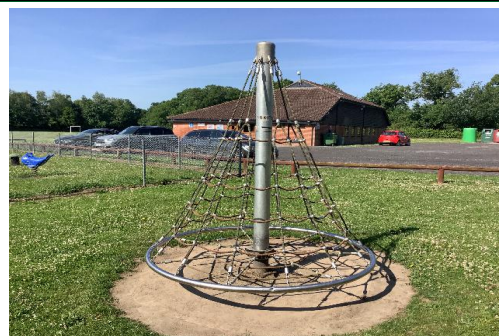
There is or are fixings missing on the item - Replace all missing fixings

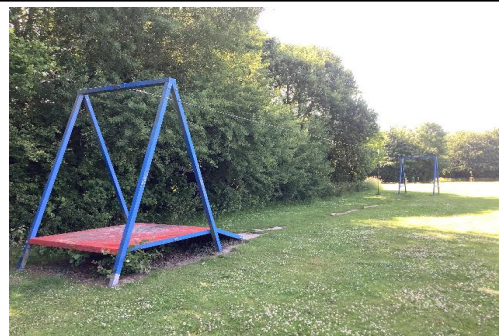
The adjacent foliage is overhanging - Cut back and maintain

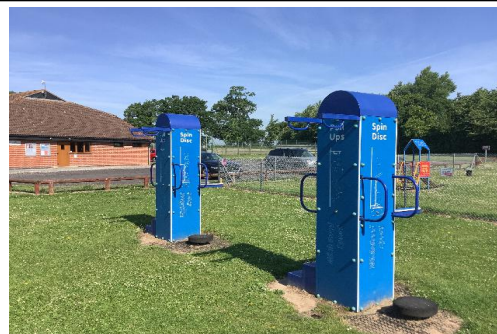
Wear to stepping discs - Monitor and replace when necessary

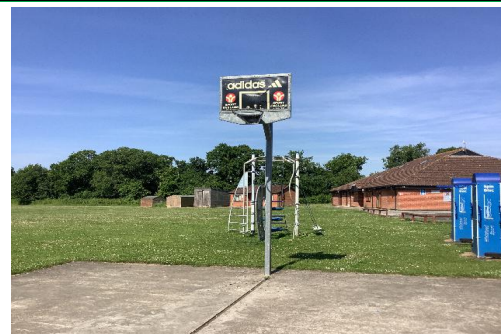
Back board damaged - Monitor and replace when necessary

Net not fitted - Fit new net

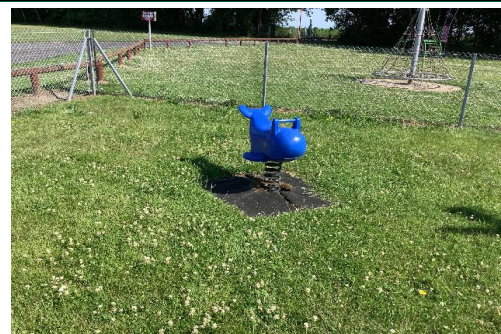
The surfacing around the item is damaged - Repair the damaged areas of surfacing

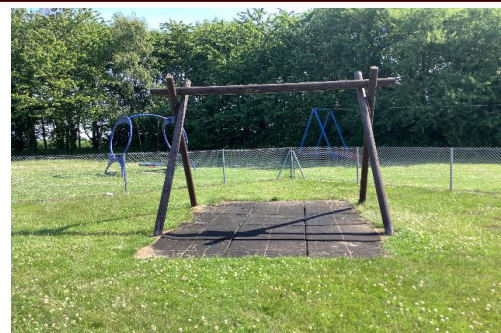
The timber on this item has severe rot - Remove and replace all affected timber sections

There are splits in the timber running through fixing points and creating some instability in the structure - Replace all affected timber parts

The surfacing around the item is damaged - Repair the damaged areas of surfacing

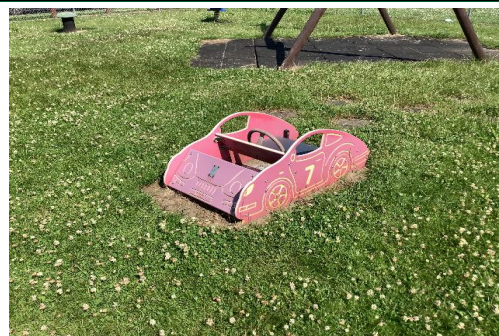
Steering wheel damaged - Replace damaged parts

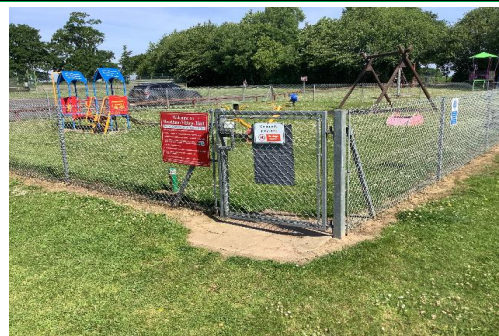
The area under the gate has broken slabs leaving uneven areas, or the concrete foundations exposed, resulting in trip hazards at the entrance/exit to the playground - Reinstate to remove trips

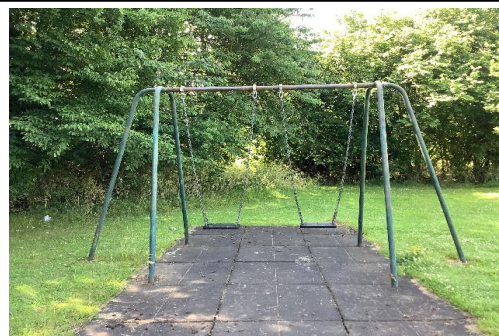
There are significant gaps (over 30mm) between the surface and the edging or between the joints in the surface; these are large enough for a small foot to enter - Repair surfacing

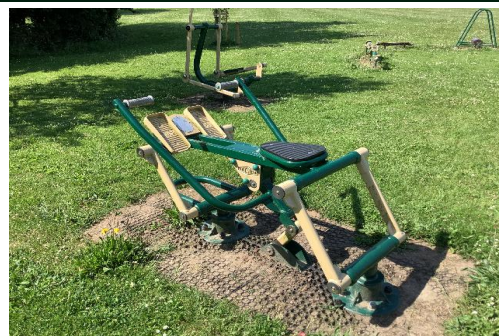
There is/are bolt cap covers missing or damaged on the item - Replace missing or damaged bolt cap covers

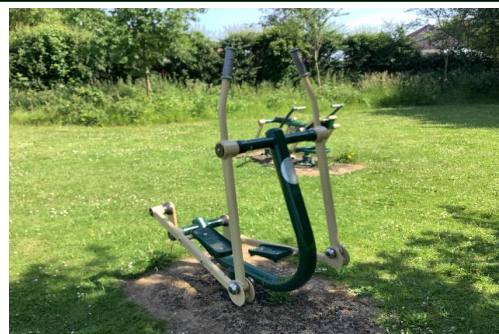
There is/are bolt cap covers missing or damaged on the item - Replace missing or damaged bolt cap covers

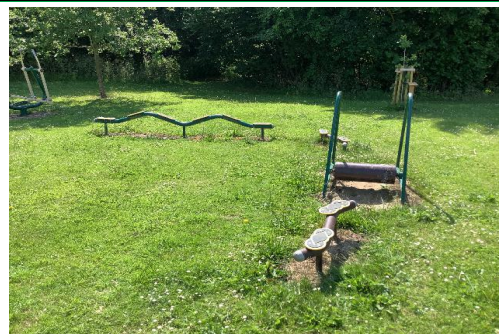
Bearing dry - Lubricate

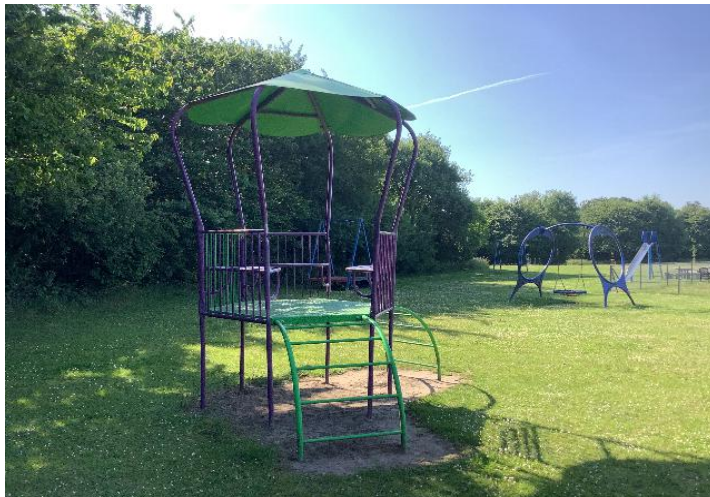
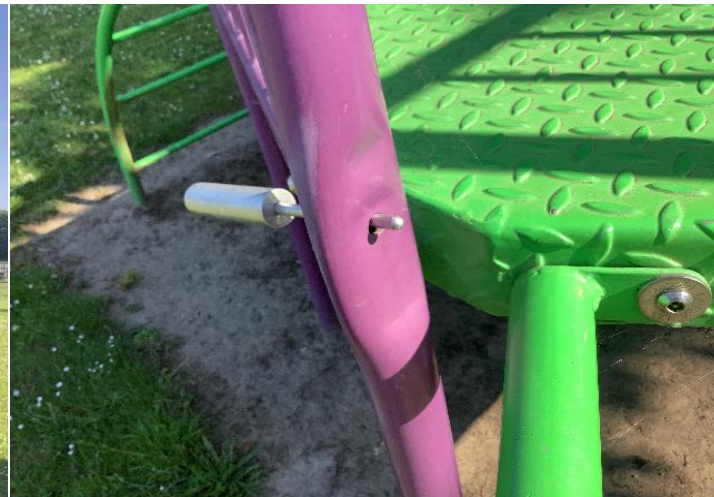
**Finding:** Finger entrapment present

**Action:** Remove finger entrapment

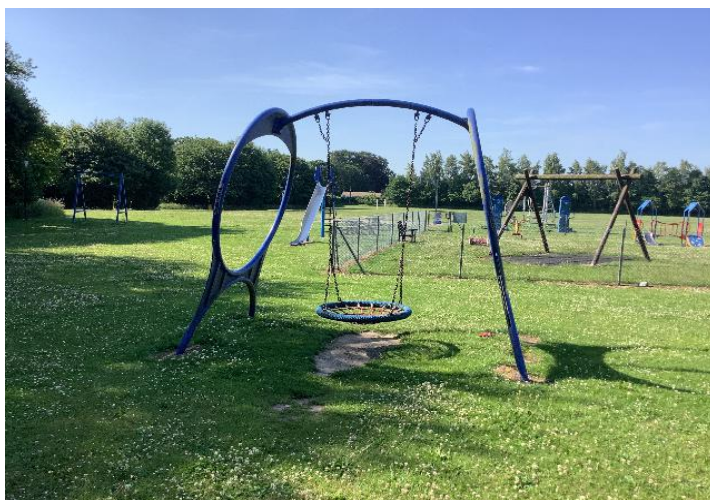
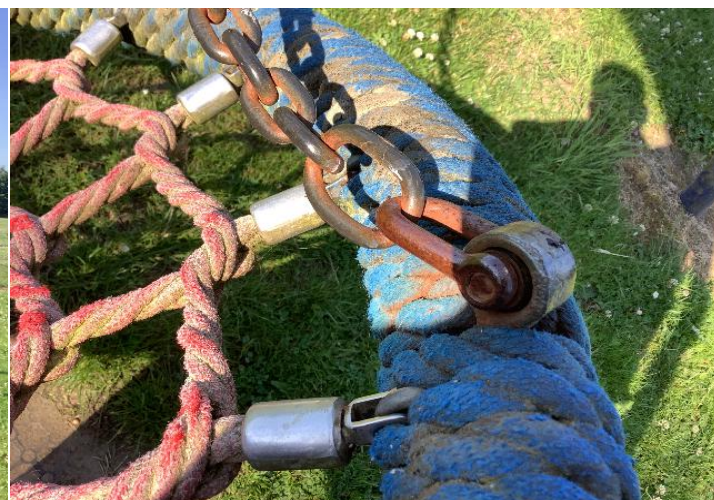
**Finding:** The bushes are worn or missing

**Action:** Replace worn or missing bushes

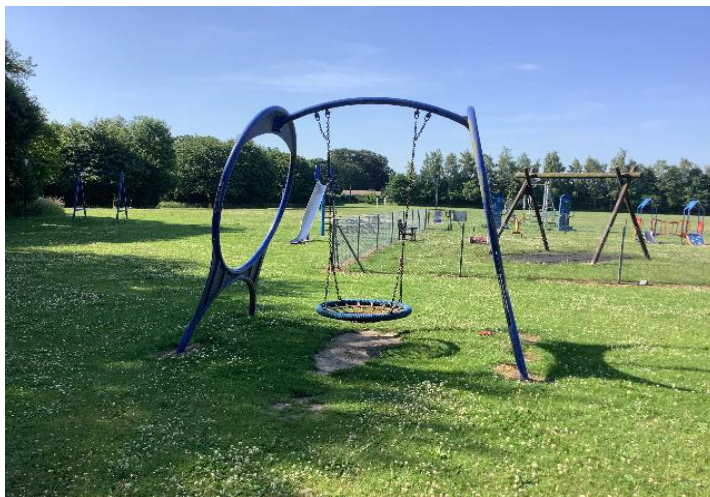
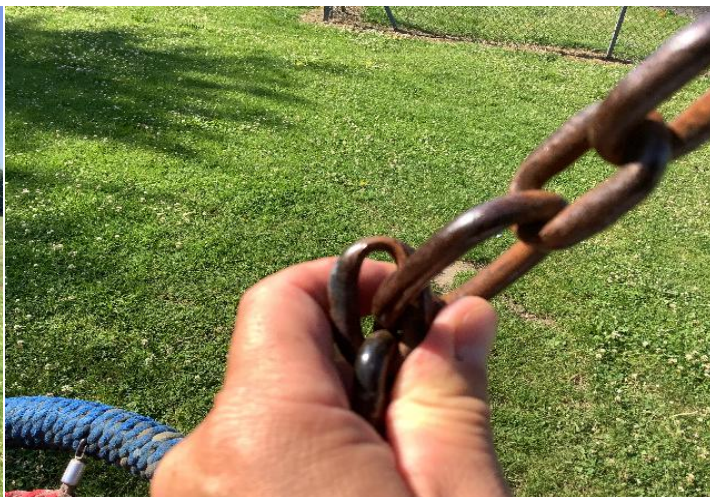
**Finding:** The chain links are worn in excess of 40% and require renewing

**Action:** Replace worn chains

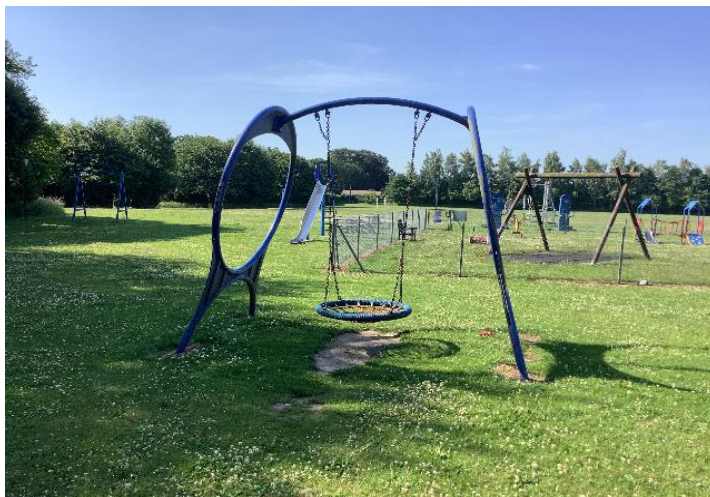
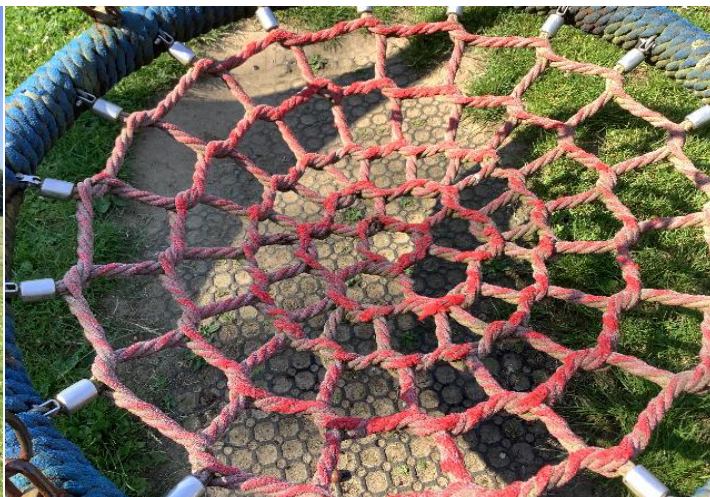
**Finding:** The seat has minor damage or wear

**Action:** Monitor for any further deterioration and replace as required

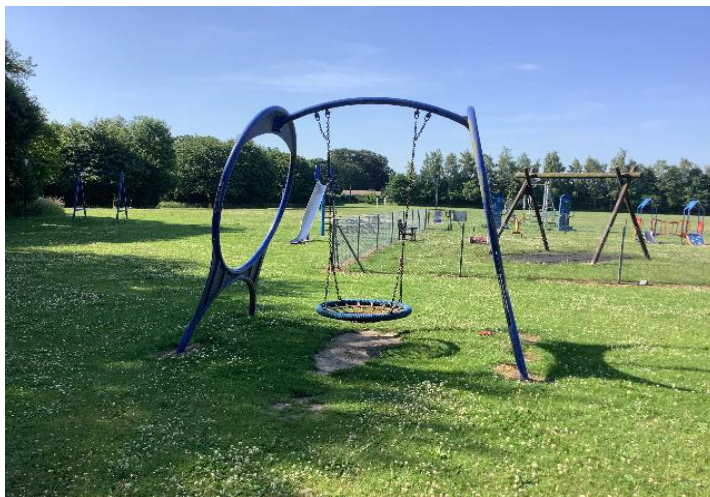
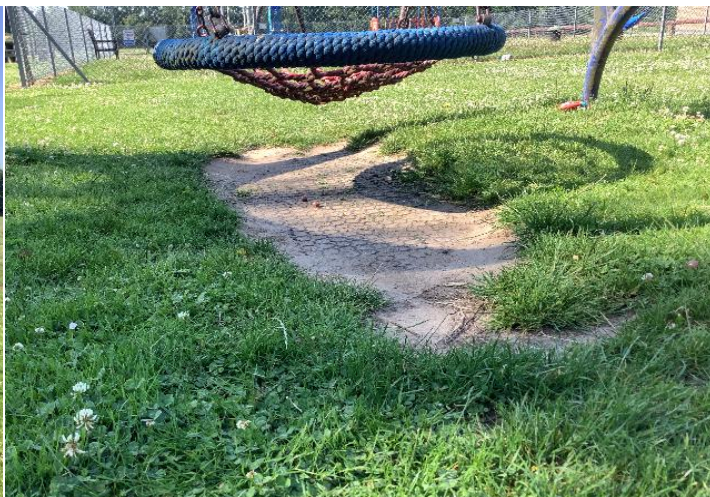
**Finding:** Seat low

**Action:** Raise to comply

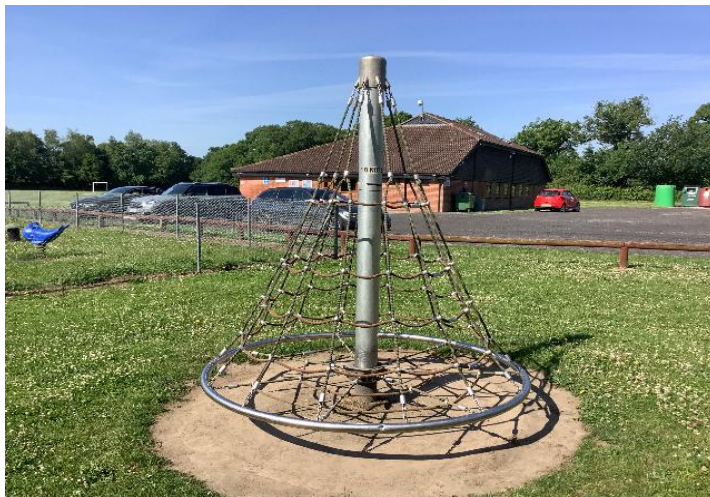
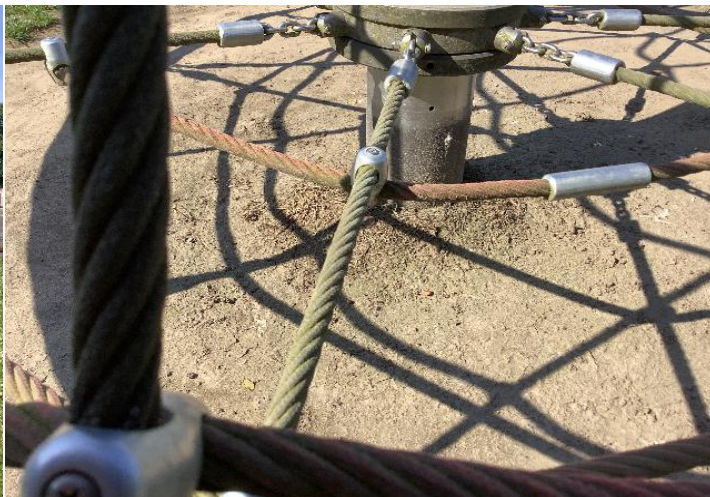
**Finding:** There is or are fixings missing on the item

**Action:** Replace all missing fixings

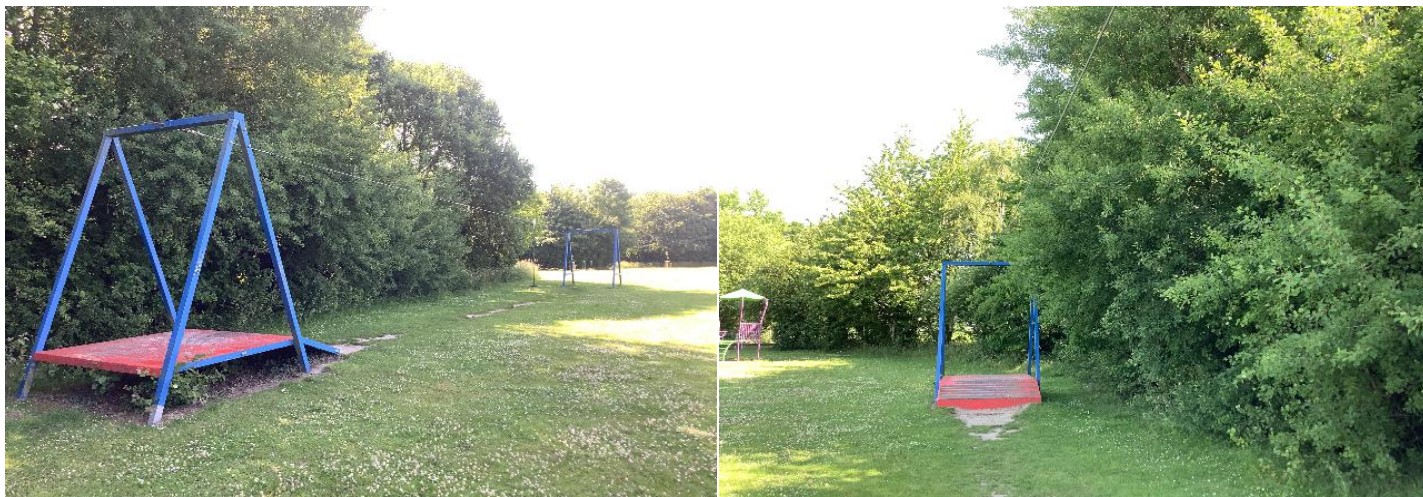
**Finding:** The adjacent foliage is overhanging

**Action:** Cut back and maintain

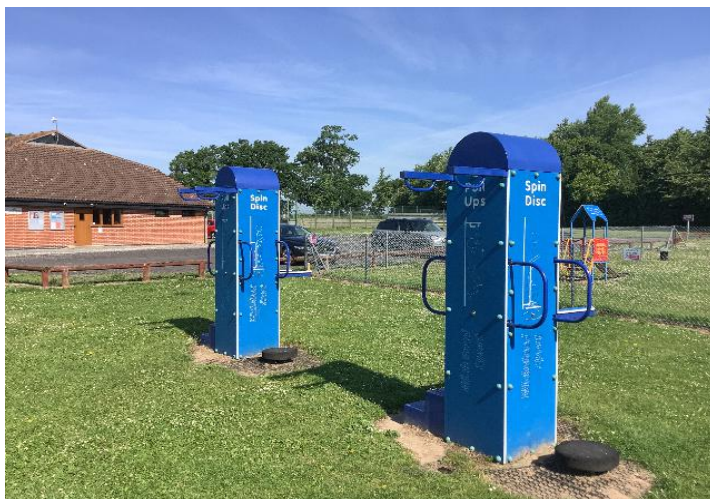
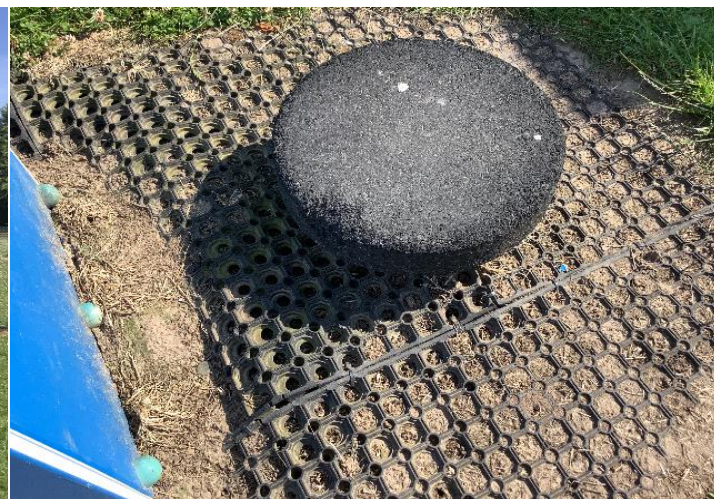
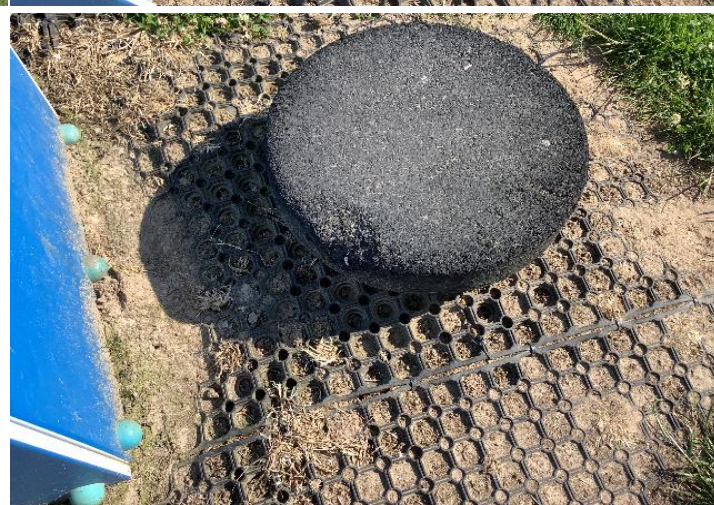
**Finding:** Wear to stepping discs

**Action:** Monitor and replace when necessary

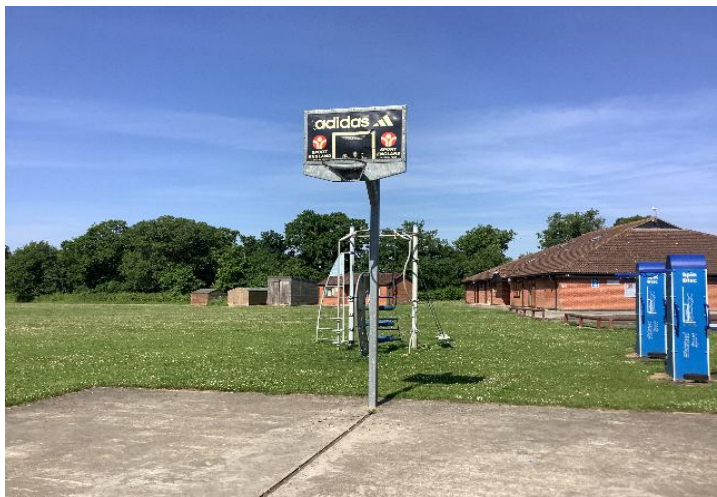
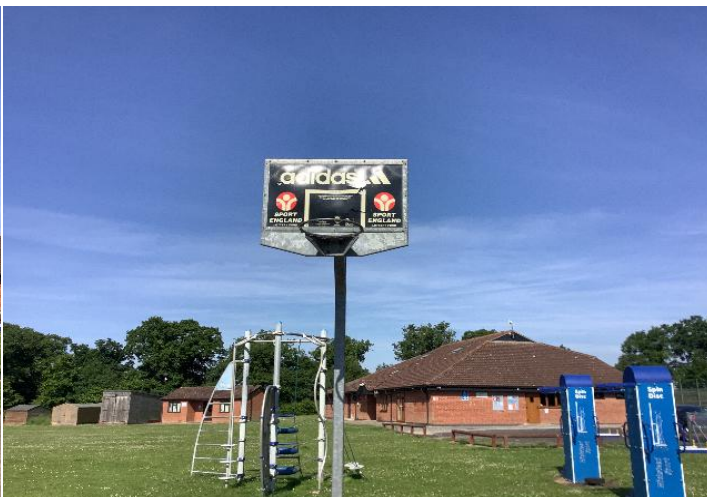
**Finding:** Back board damaged

**Action:** Monitor and replace when necessary

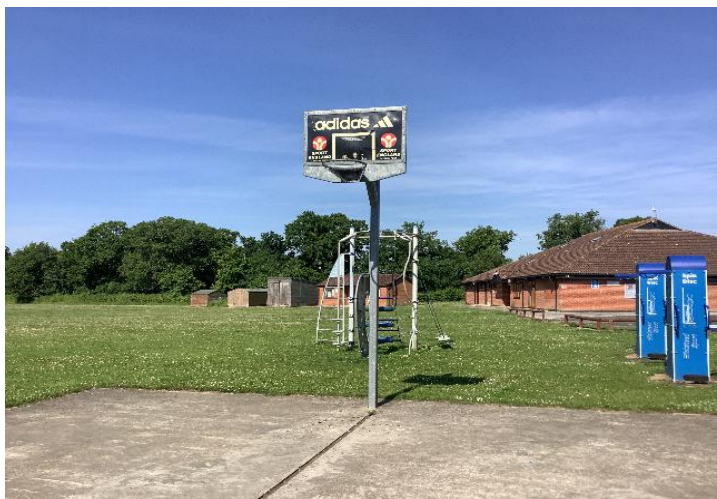
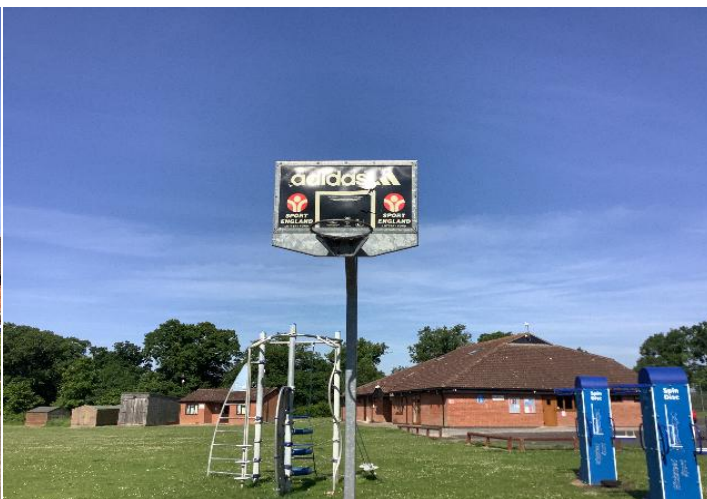
**Finding:** Net not fitted

**Action:** Fit new net

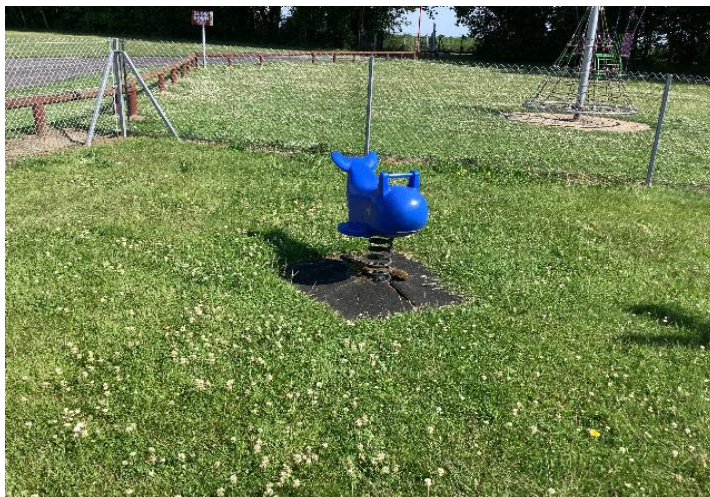
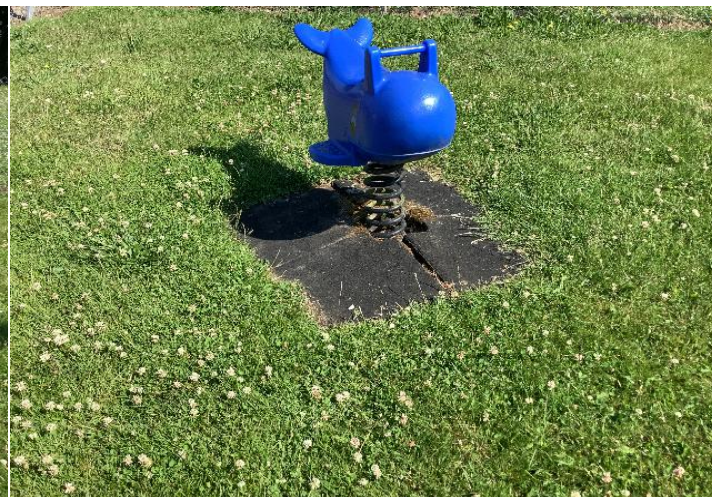
**Finding:** The surfacing around the item is damaged

**Action:** Repair the damaged areas of surfacing

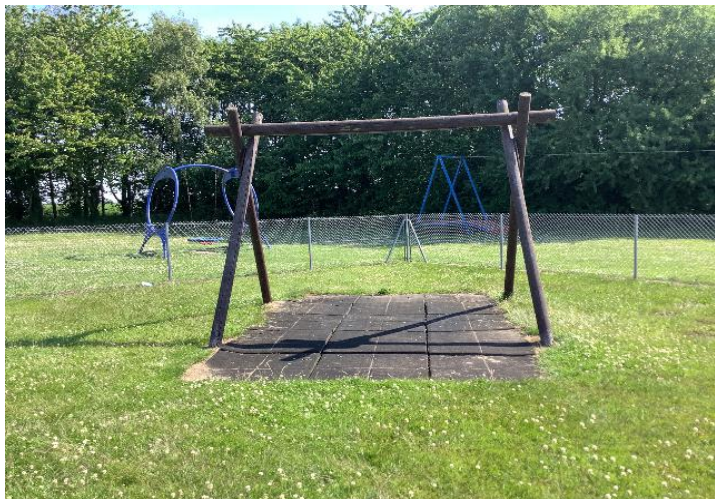
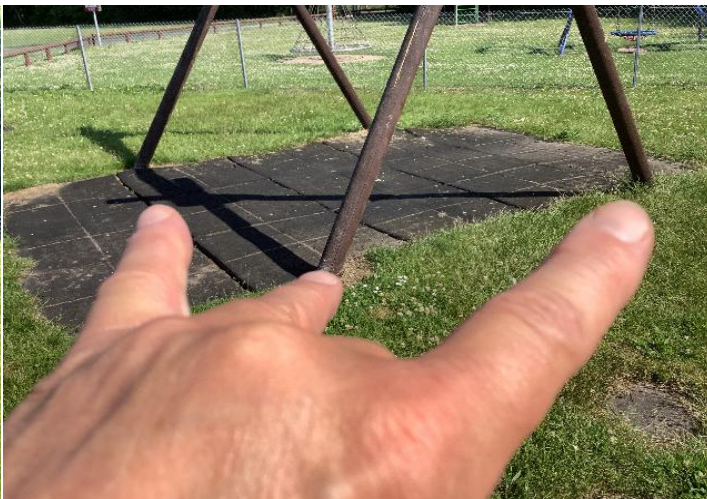
**Risk Level:** H - High Risk

**Finding:** The timber on this item has severe rot

**Action:** Remove and replace all affected timber sections

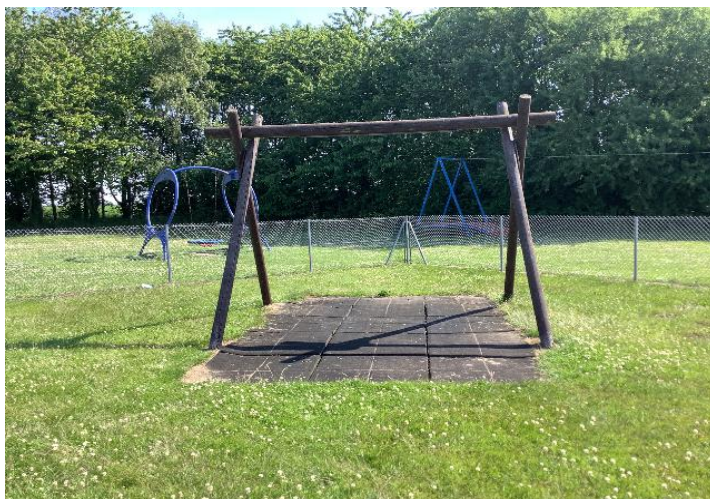
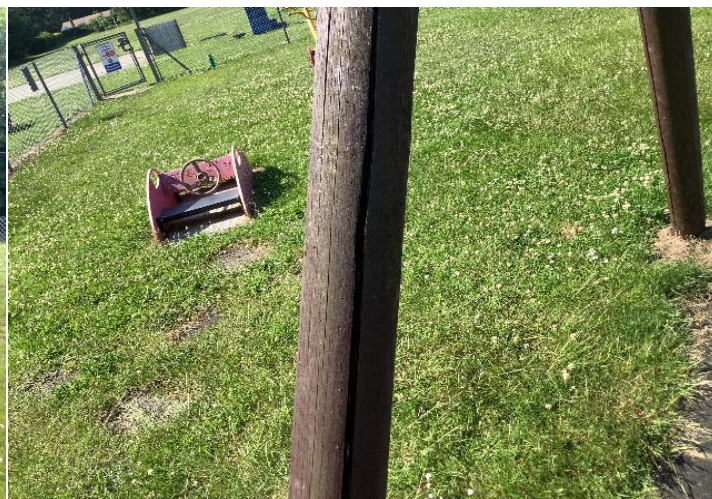
**Finding:** There are splits in the timber running through fixing points and creating some instability in the structure **Action:** Replace all affected timber parts

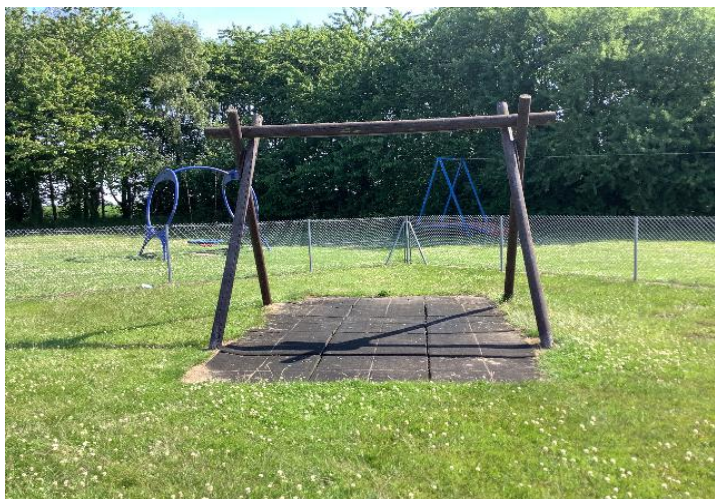
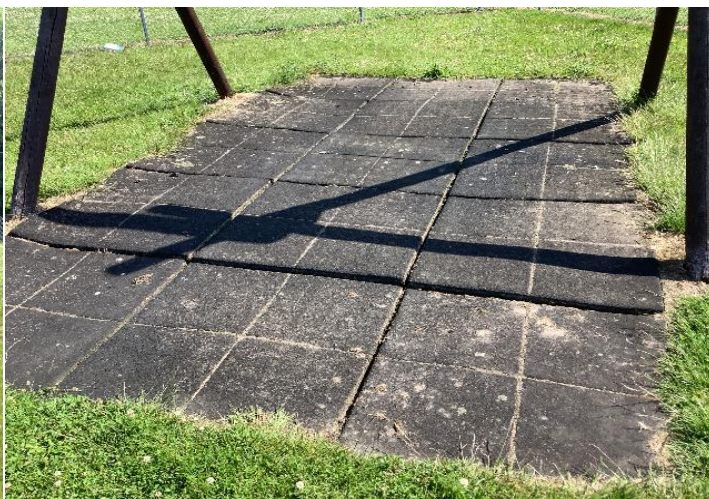
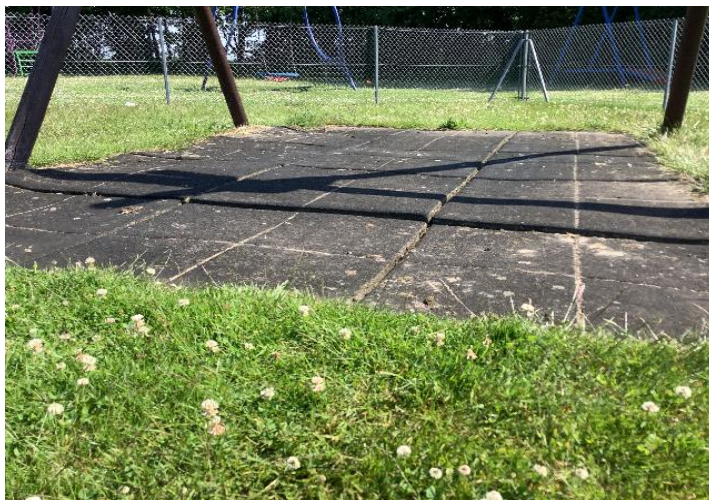
**Finding:** The surfacing around the item is damaged

**Action:** Repair the damaged areas of surfacing

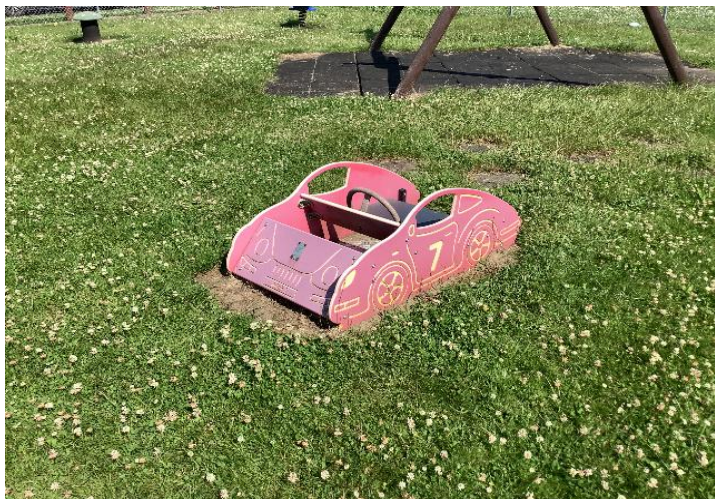
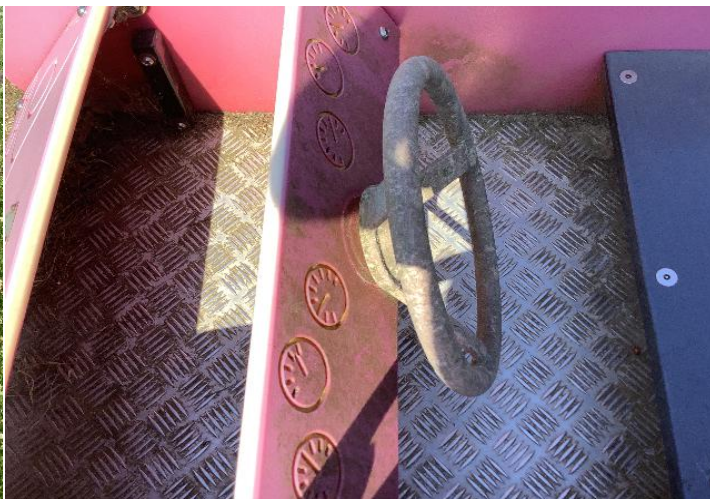
**Finding:** Steering wheel damaged

**Action:** Replace damaged parts

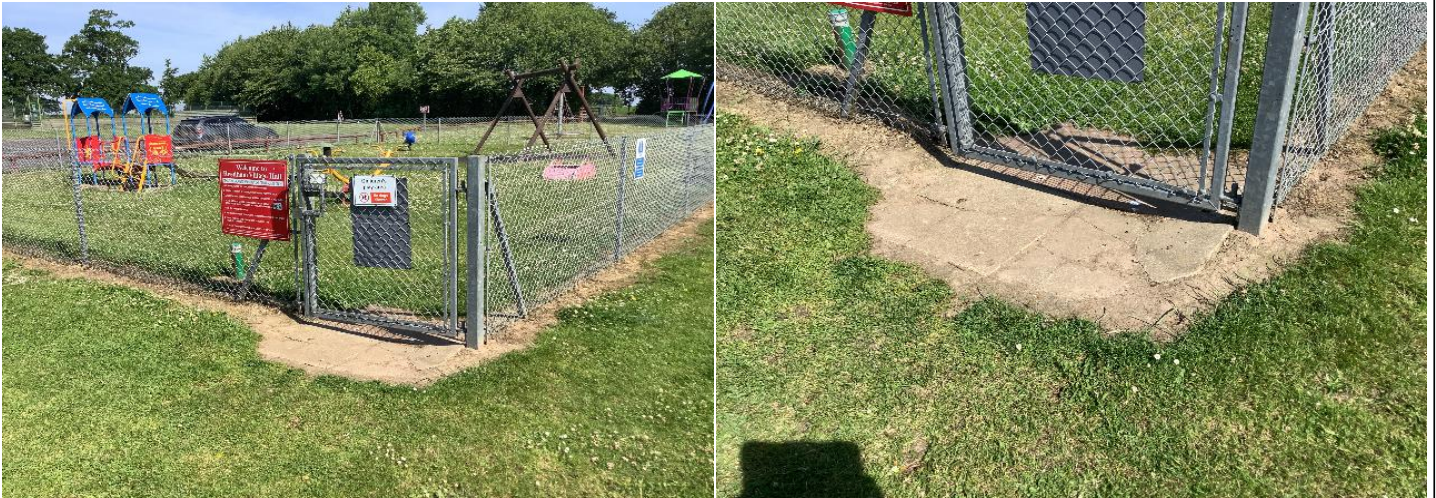
**Finding:** The area under the gate has broken slabs leaving uneven areas, or the concrete foundations exposed, resulting in trip hazards at the entrance/exit to the playground  
**Action:** Reinstate to remove trips

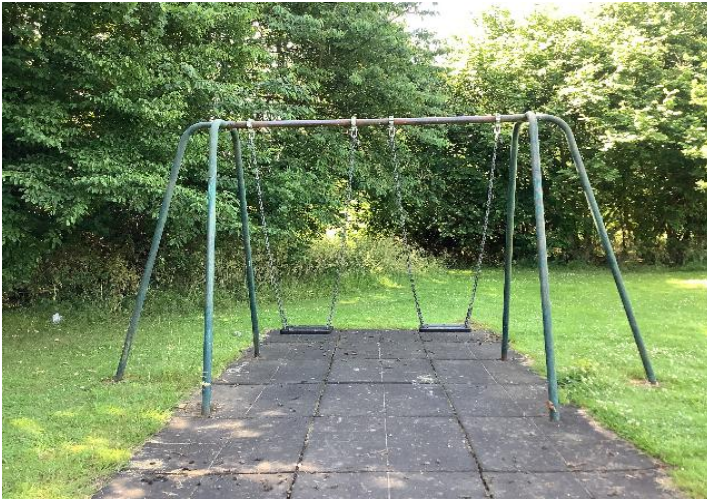
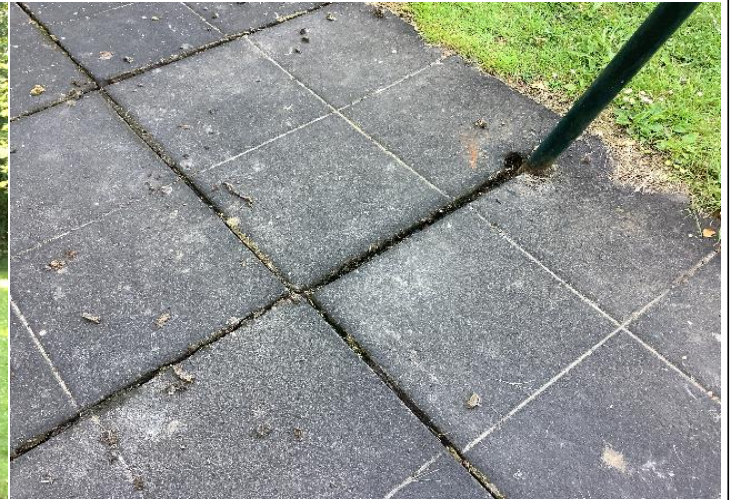
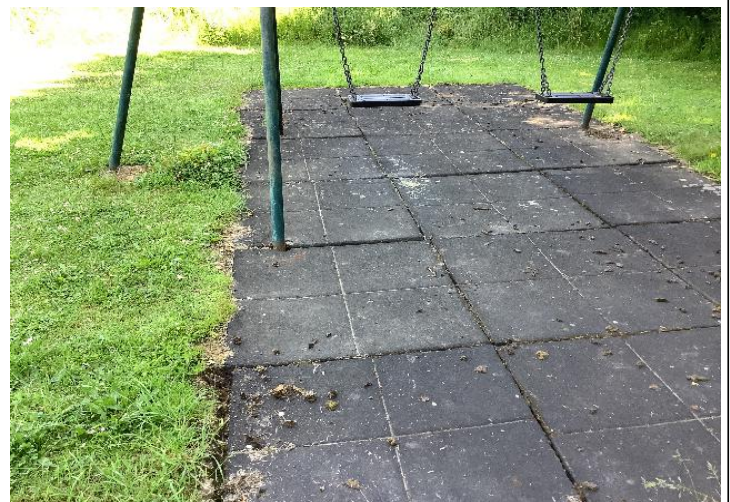
**Finding:** There are significant gaps (over 30mm) between the surface and the edging or between the joints in the surface; these are large enough for a small foot to enter

**Action:** Repair surfacing

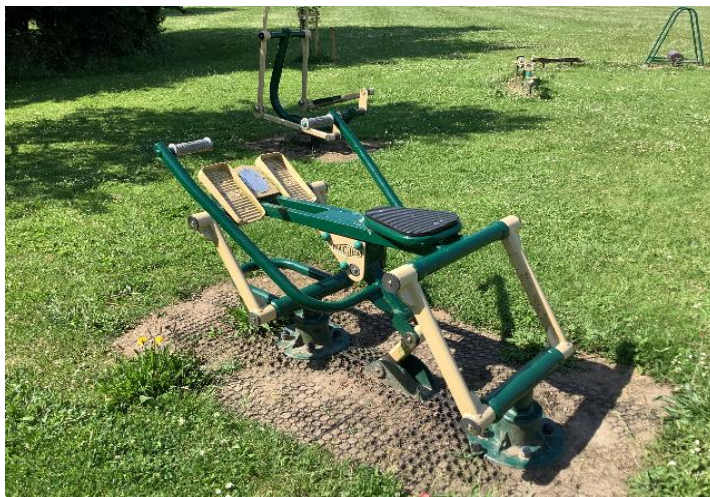
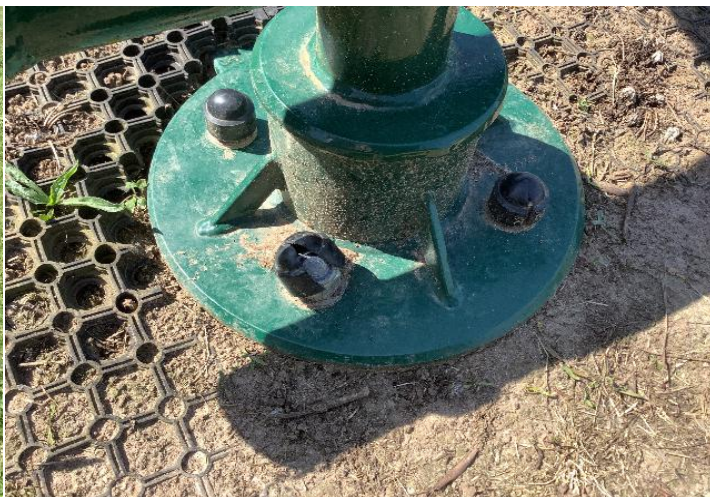
**Finding:** There is/are bolt cap covers missing or damaged on the item

**Action:** Replace missing or damaged bolt cap covers

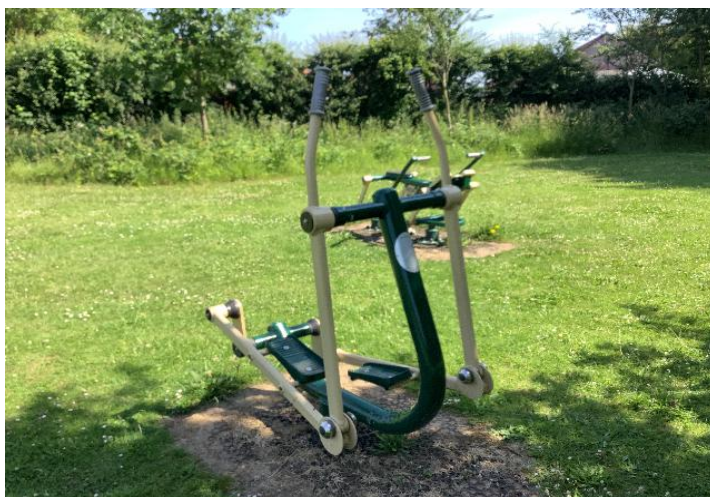
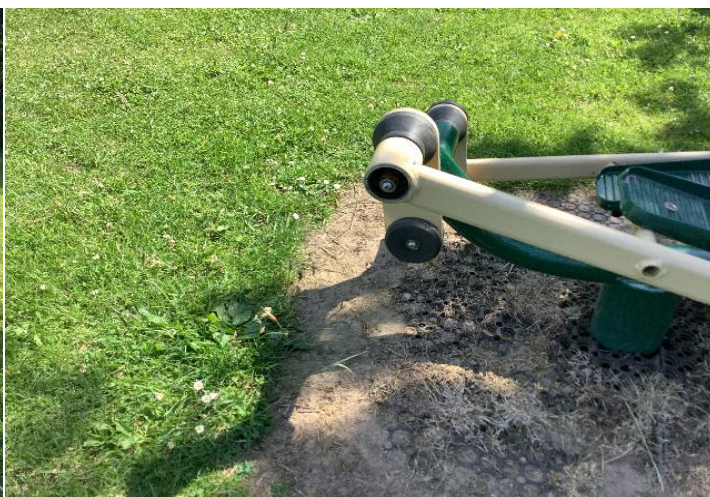
**Finding:** There is/are bolt cap covers missing or damaged on the item

**Action:** Replace missing or damaged bolt cap covers

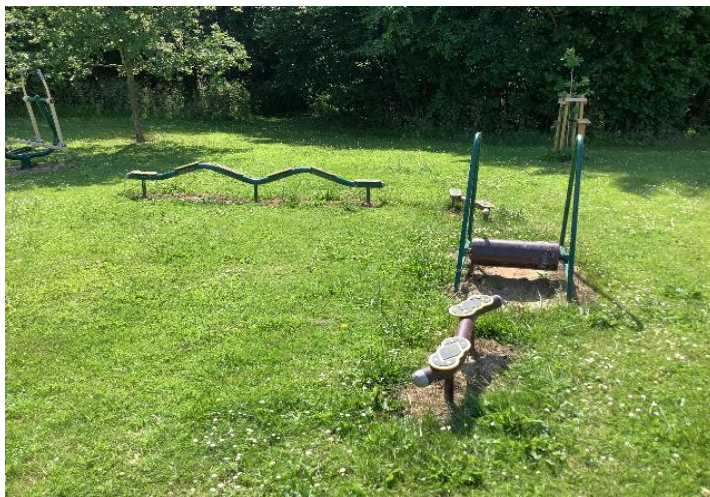
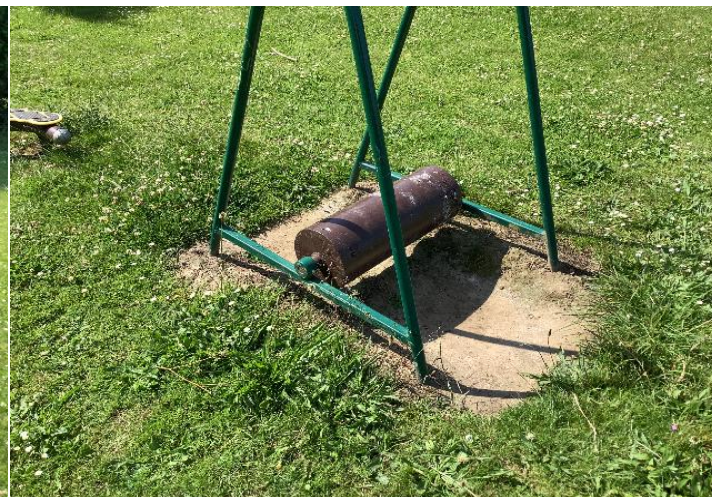
**Finding:** Bearing dry

**Action:** Lubricate
