## Operational Inspection

Reedham Village Hall

Reedham Village Hall  
Pottle's Lane, Reedham, Norwich, NR13 3HL

Operational Inspection - 15-June-2022 - 08:53 Inspector Martyn Lilley

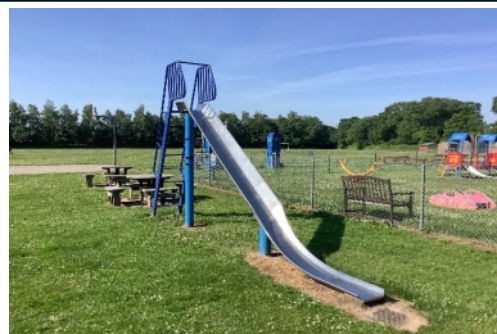
**Item:** Free Standing Slide  
**Manufacturer:** Owner/Operator  
**Surface Type:** Grass Matrix Tiles  
**Item Quantity:** 1  
**Equipment Compliance:** N/A  
**Surface Area Compliance:** N/A

**Finding 1**

This item is satisfactory - no work required -

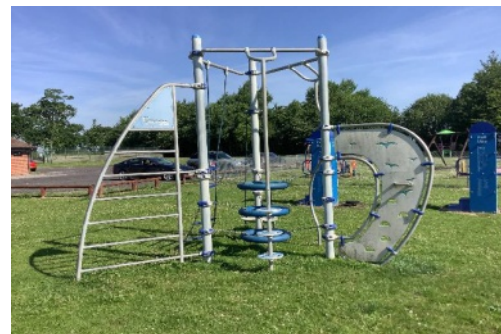
**Item:** Climbing Frame  
**Manufacturer:** Wicksteed Playgrounds  
**Surface Type:** Grass Matrix Tiles  
**Item Quantity:** 1  
**Equipment Compliance:** N/A  
**Surface Area Compliance:** N/A

**Finding 1**

This item is satisfactory - no work required -

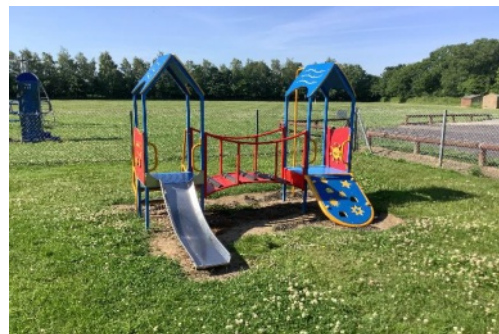
**Item:** Multi Play (Toddler)  
**Manufacturer:** Wicksteed Playgrounds  
**Surface Type:** Grass Matrix Tiles  
**Item Quantity:** 1  
**Equipment Compliance:** N/A  
**Surface Area Compliance:** N/A

**Finding 1**

This item is satisfactory - no work required -

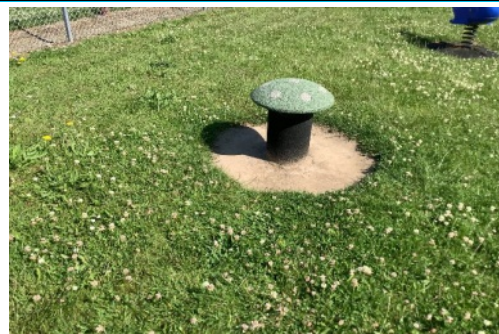
**Item:** Toadstools & Table  
**Manufacturer:** Owner/Operator  
**Surface Type:** Compacted Earth  
**Item Quantity:** 1  
**Equipment Compliance:** N/A  
**Surface Area Compliance:** N/A

**Finding 1**

This item is satisfactory - no work required -

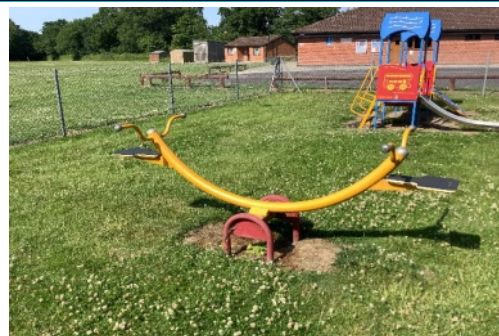
**Item:** See Saw  
**Manufacturer:** Wicksteed Playgrounds  
**Surface Type:** Grass Matrix Tiles  
**Item Quantity:** 1  
**Equipment Compliance:** N/A  
**Surface Area Compliance:** N/A

**Finding 1**

This item is satisfactory - no work required -

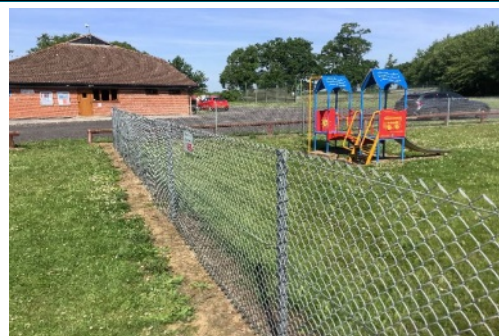
**Item:** Fence - Chainlink  
**Manufacturer:** Owner/Operator  
**Surface Type:** Grass  
**Item Quantity:** 1  
**Equipment Compliance:** N/A  
**Surface Area Compliance:** N/A

**Finding 1**

This item is satisfactory - no work required -
